PHOTO 6 EXISTING CONDITIONS

OCTOBER 24, 2024

## HAYSTACK CHANNEL REHABILITATION

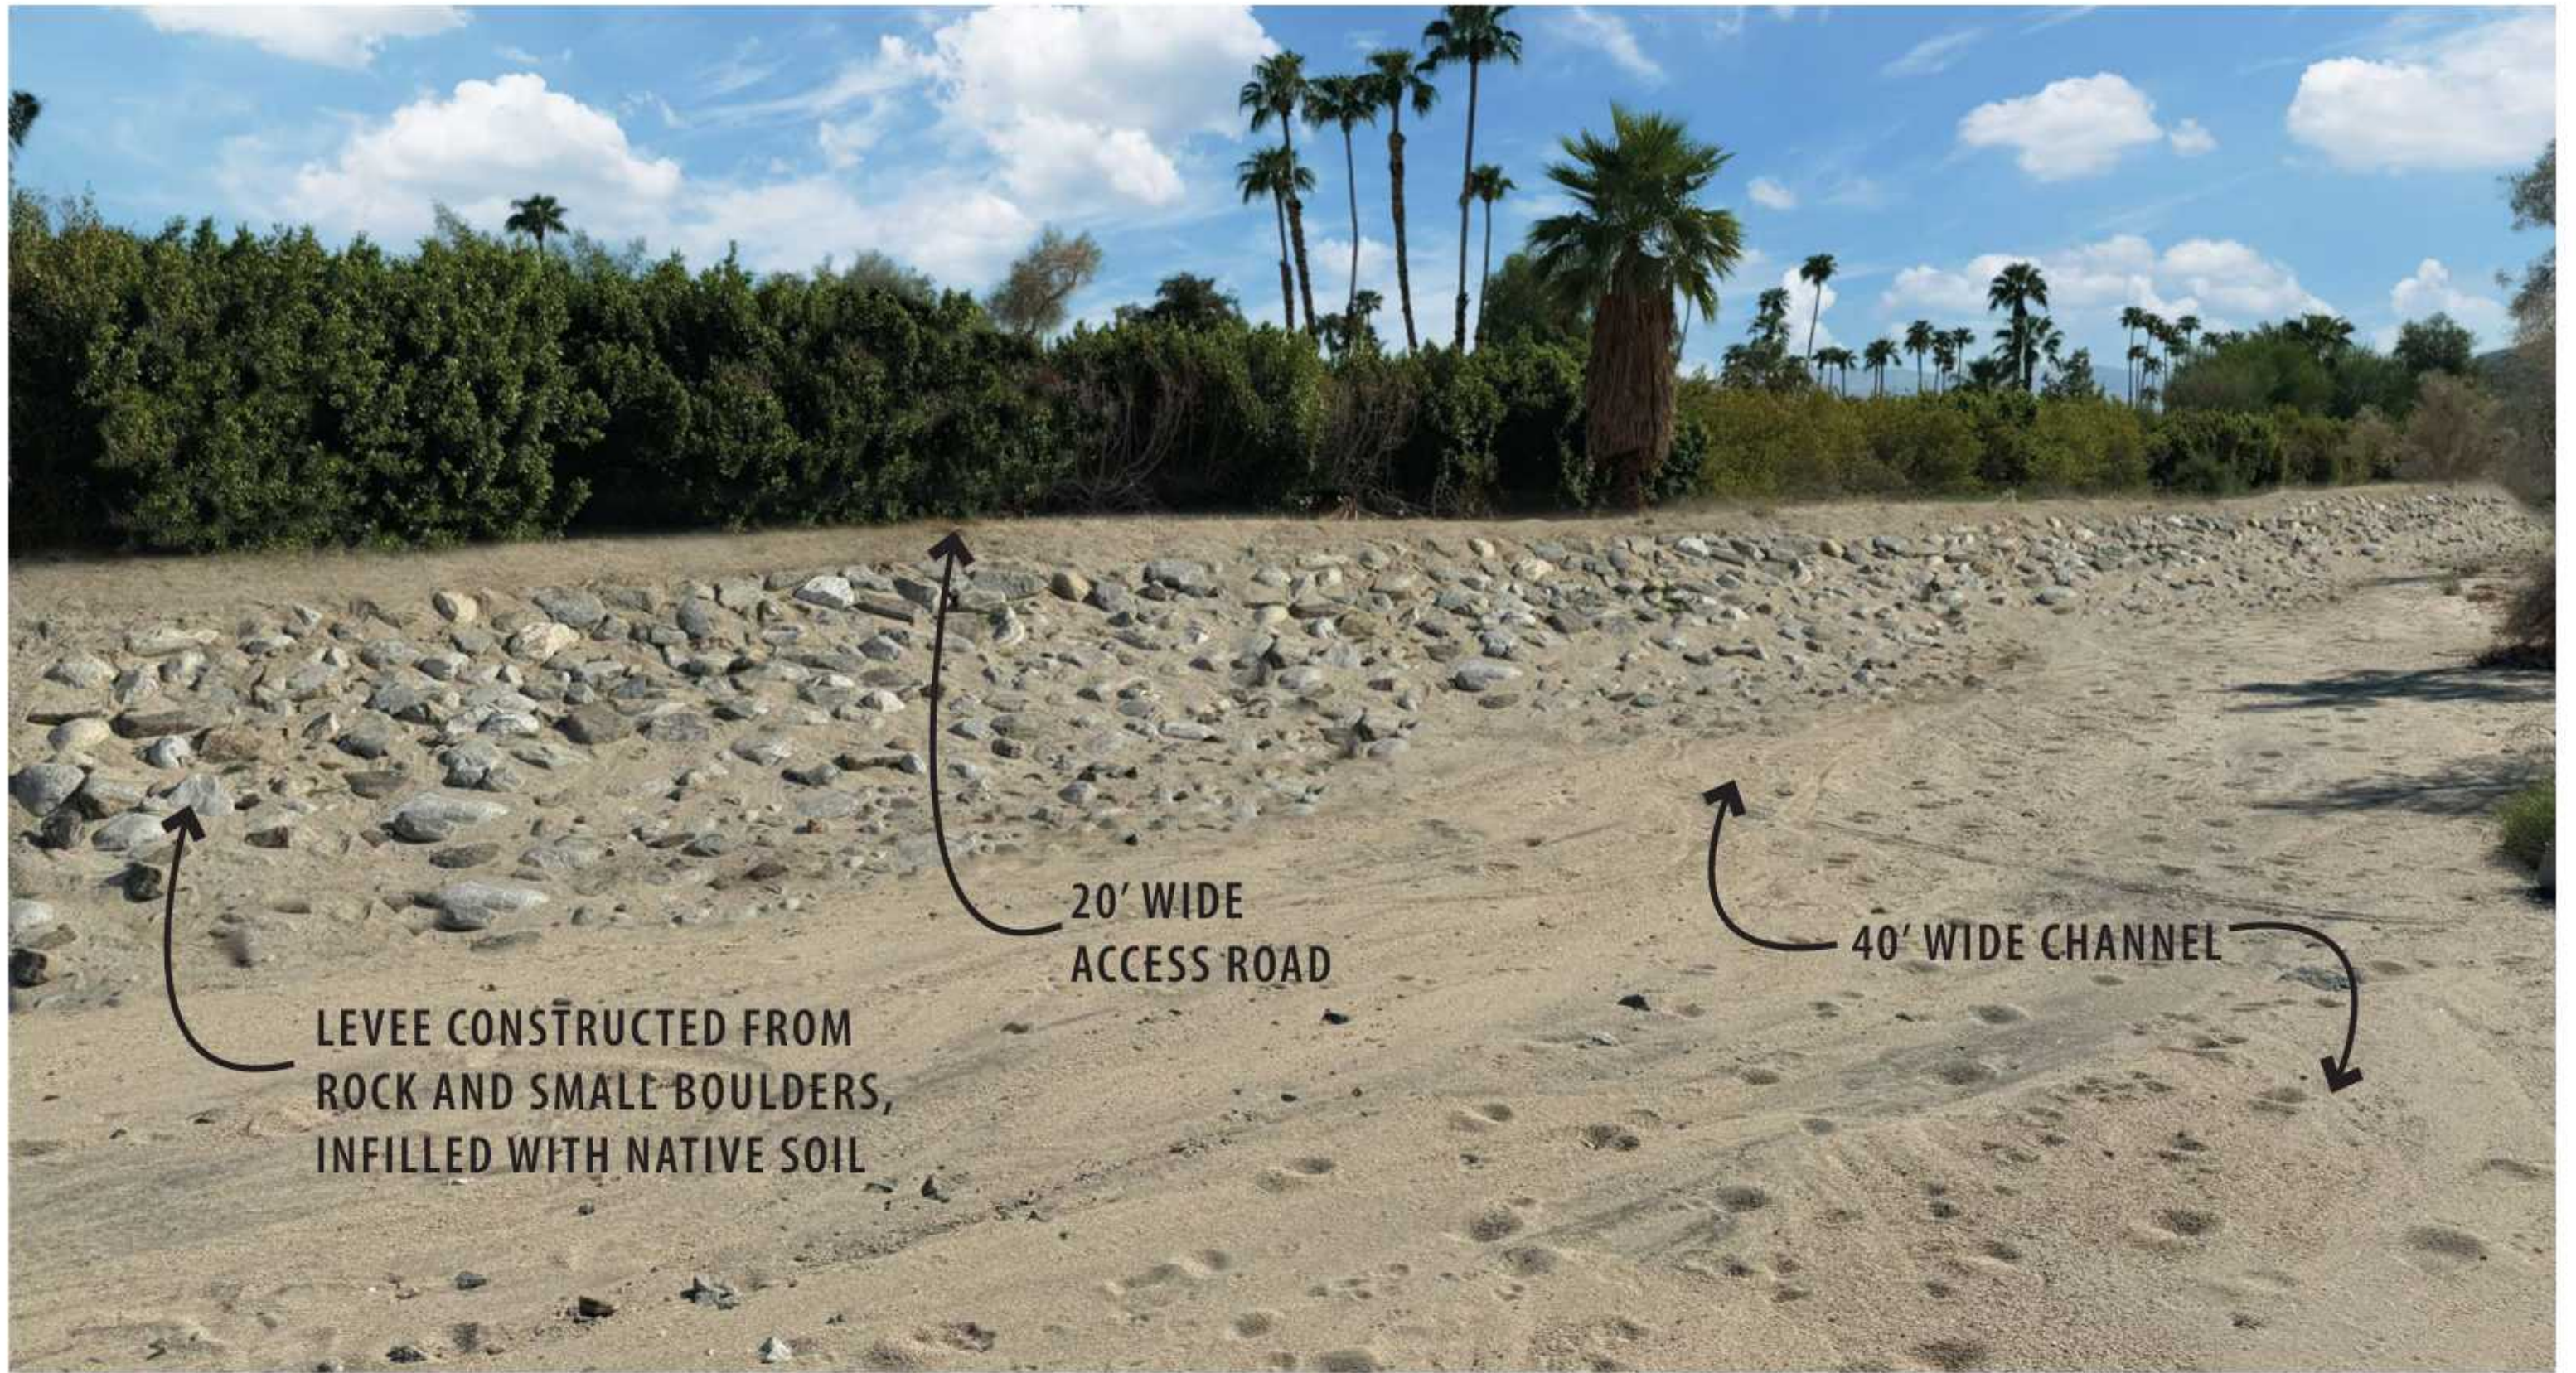
PHOTO 6 PROPOSED CHANNEL IMPROVEMENTS AT INSTALL

LEVEE CONSTRUCTED FROM  
ROCK AND SMALL BOULDERS,  
INFILLED WITH NATIVE SOIL

20' WIDE  
ACCESS ROAD

40' WIDE CHANNEL

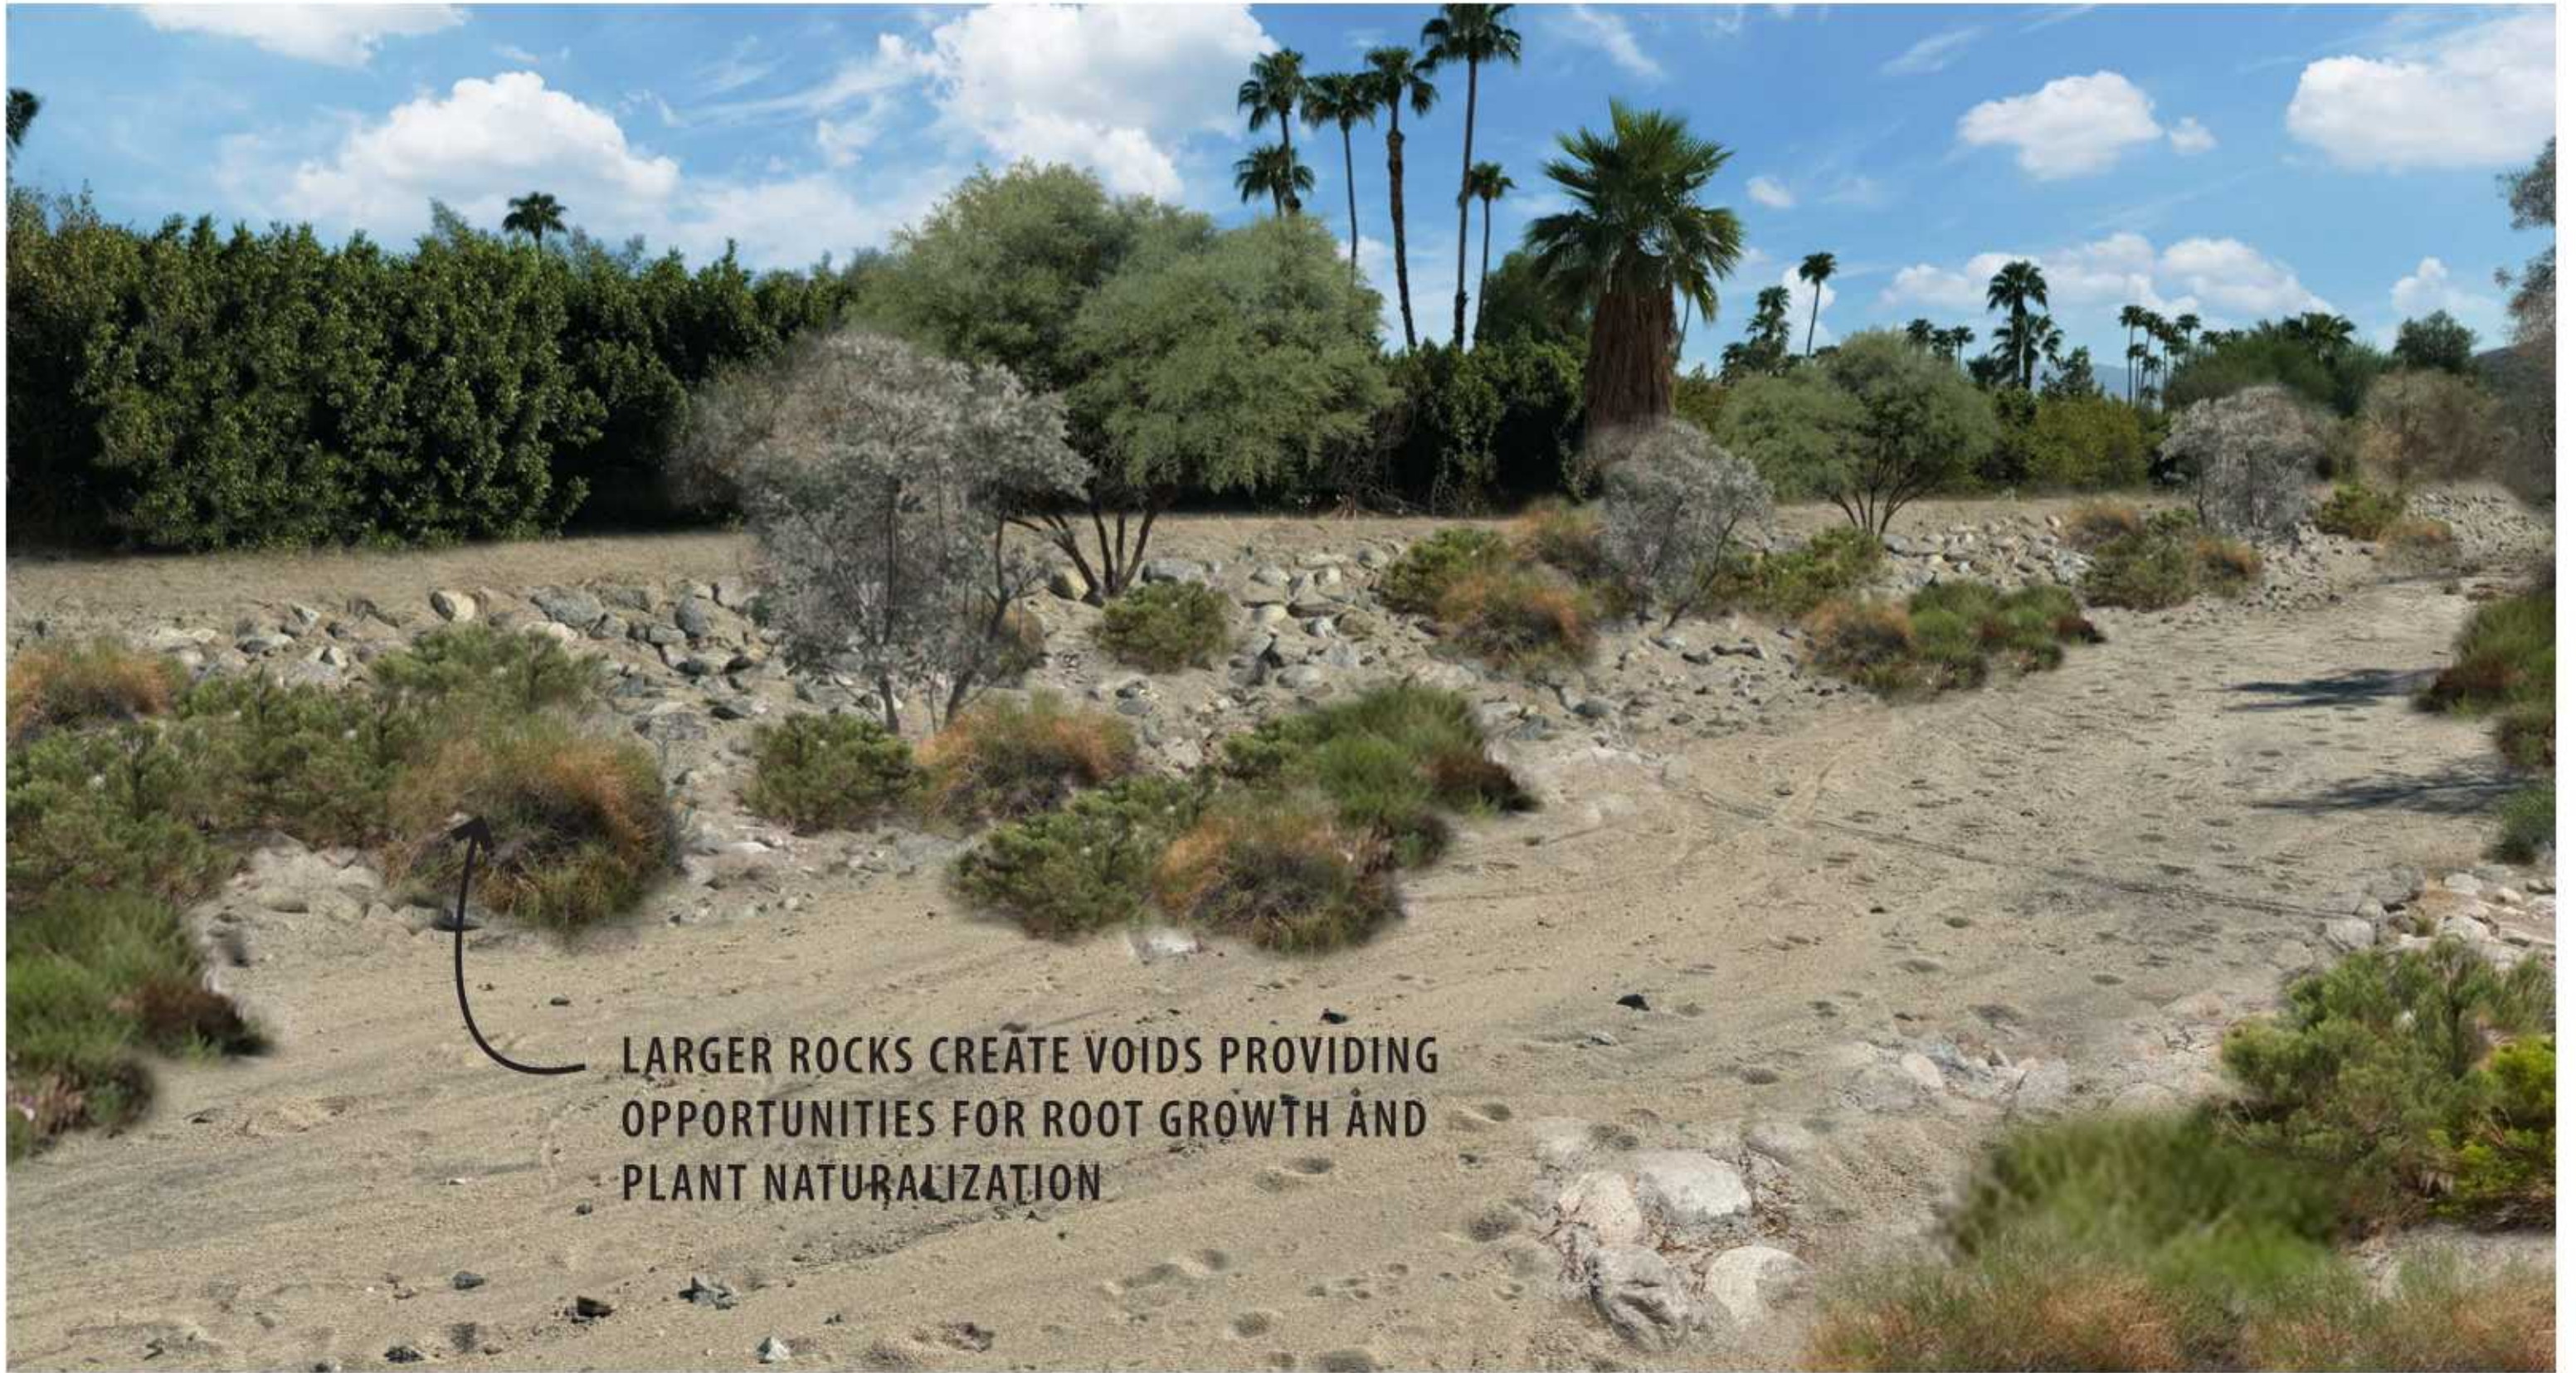
PHOTO 6 PROPOSED CHANNEL IMPROVEMENTS AT MATURITY

LARGER ROCKS CREATE VOIDS PROVIDING OPPORTUNITIES FOR ROOT GROWTH AND PLANT NATURALIZATION

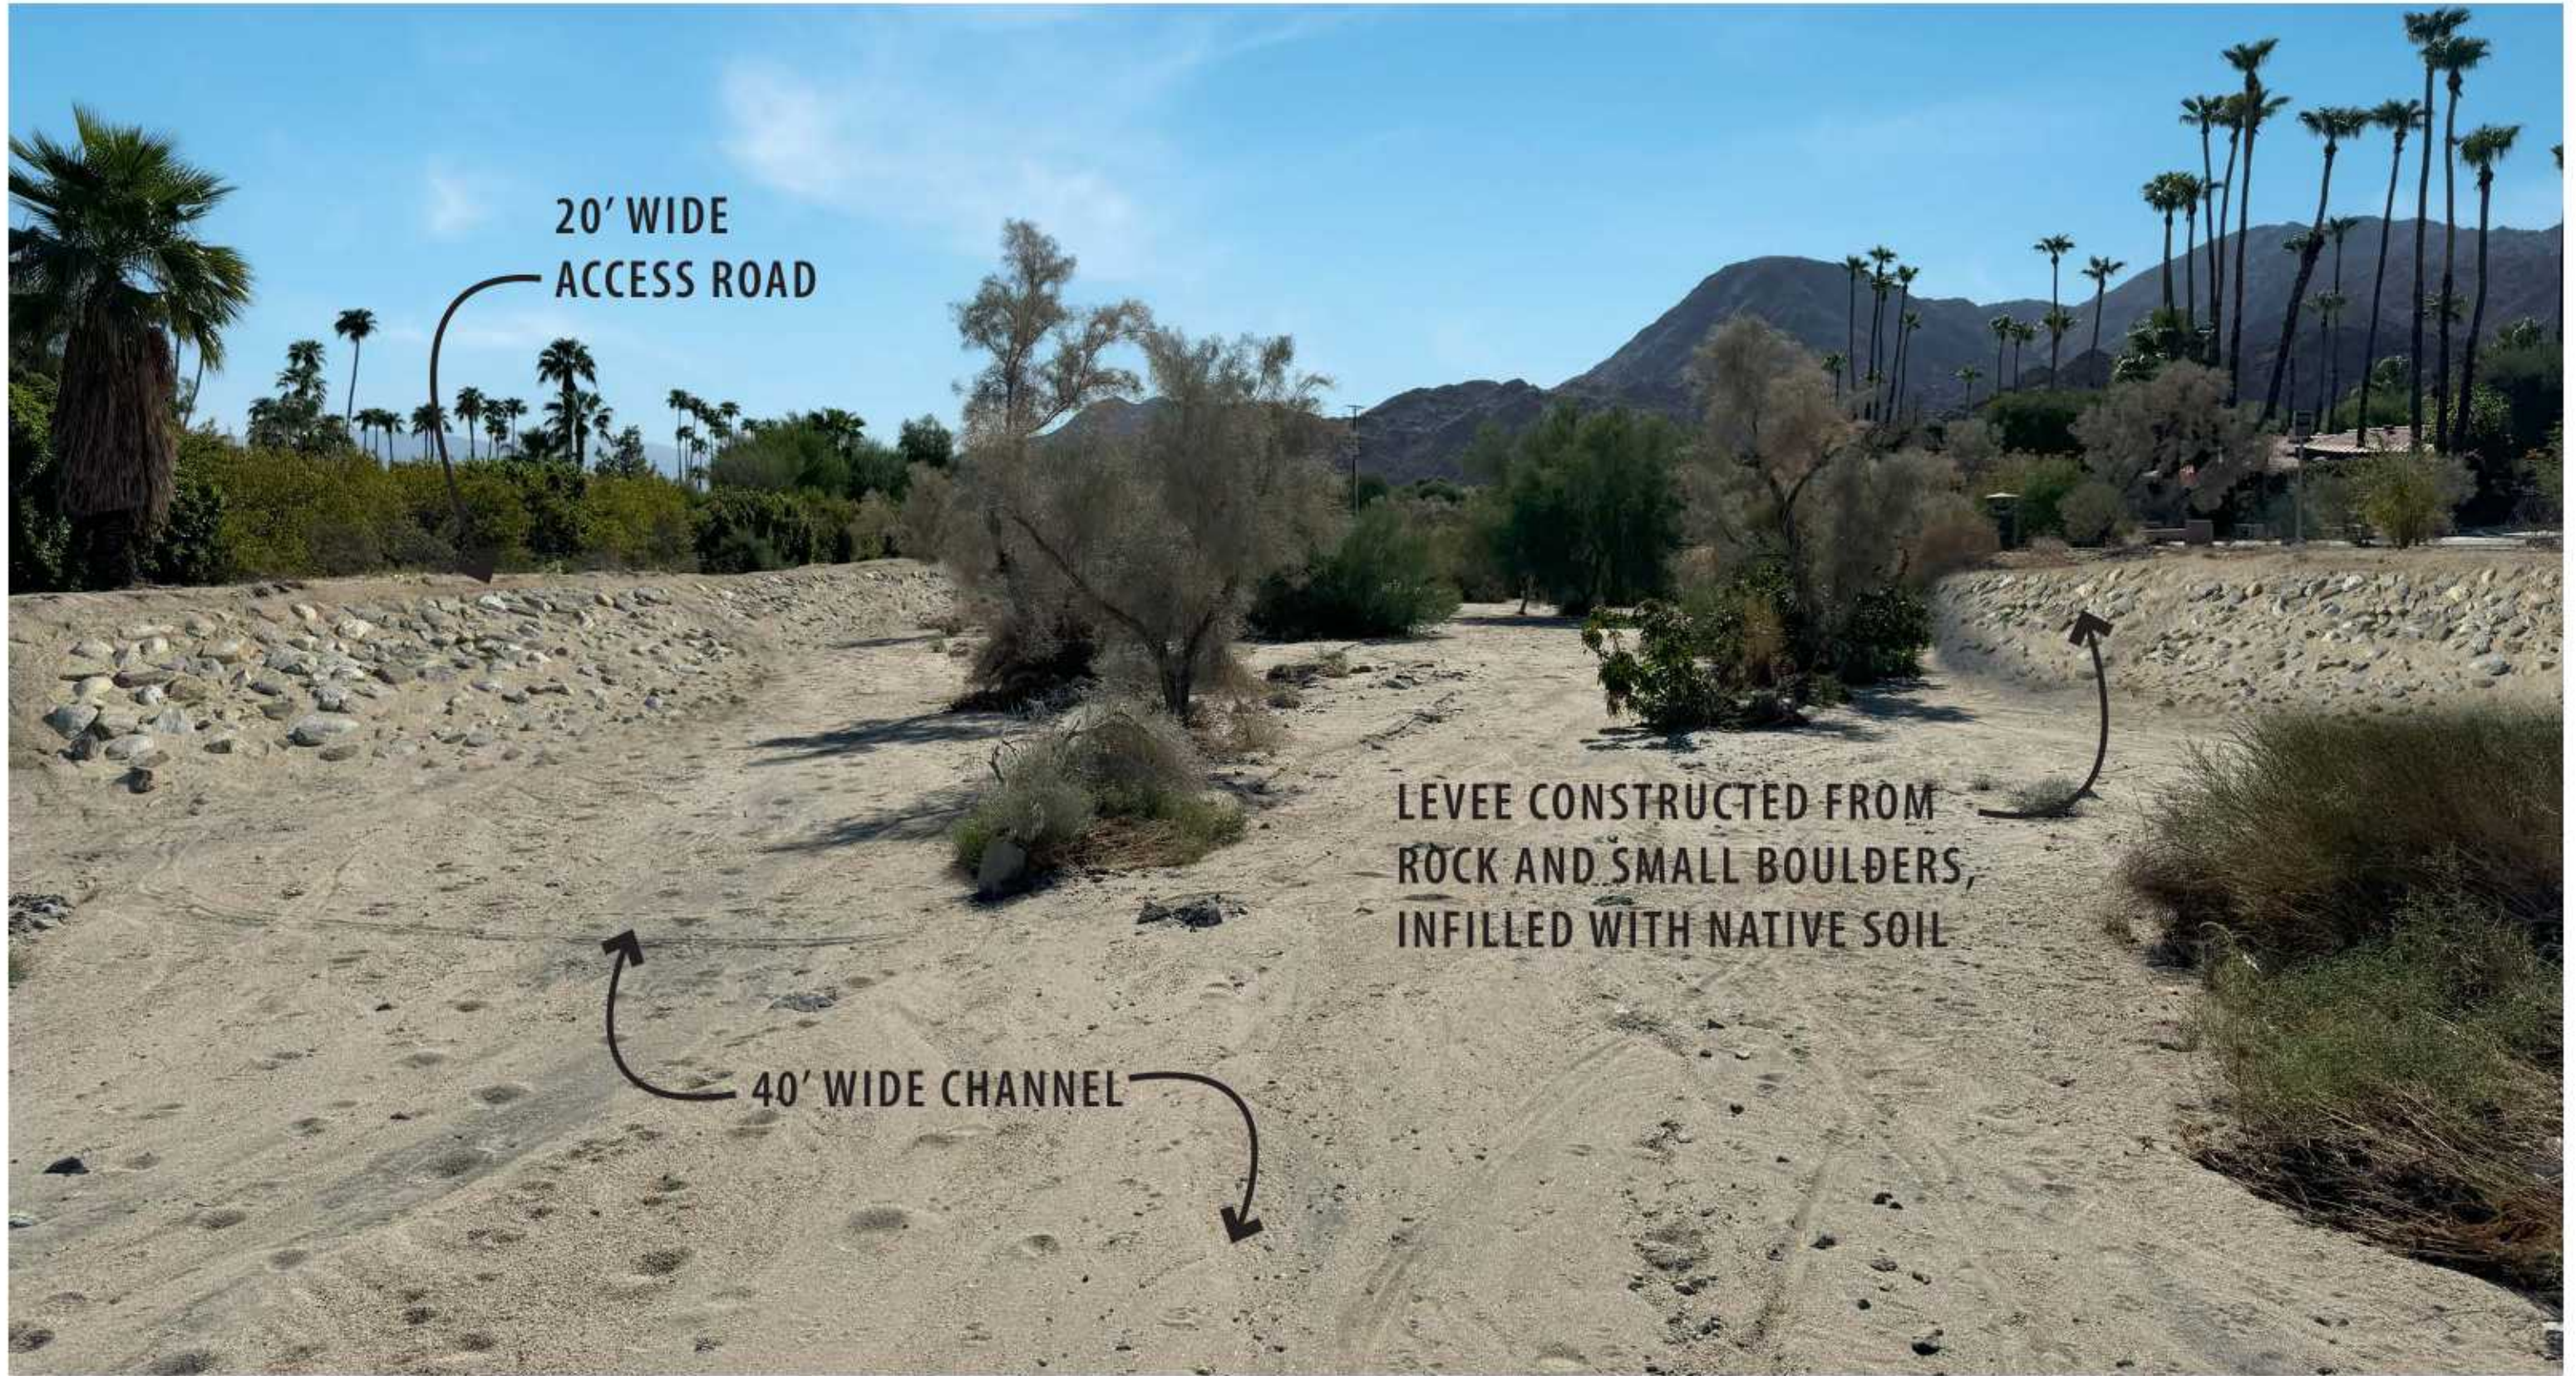
PHOTO 7 PROPOSED CHANNEL IMPROVEMENTS AT INSTALL

20' WIDE  
ACCESS ROAD

LEVEE CONSTRUCTED FROM  
ROCK AND SMALL BOULDERS,  
INFILLED WITH NATIVE SOIL

40' WIDE CHANNEL

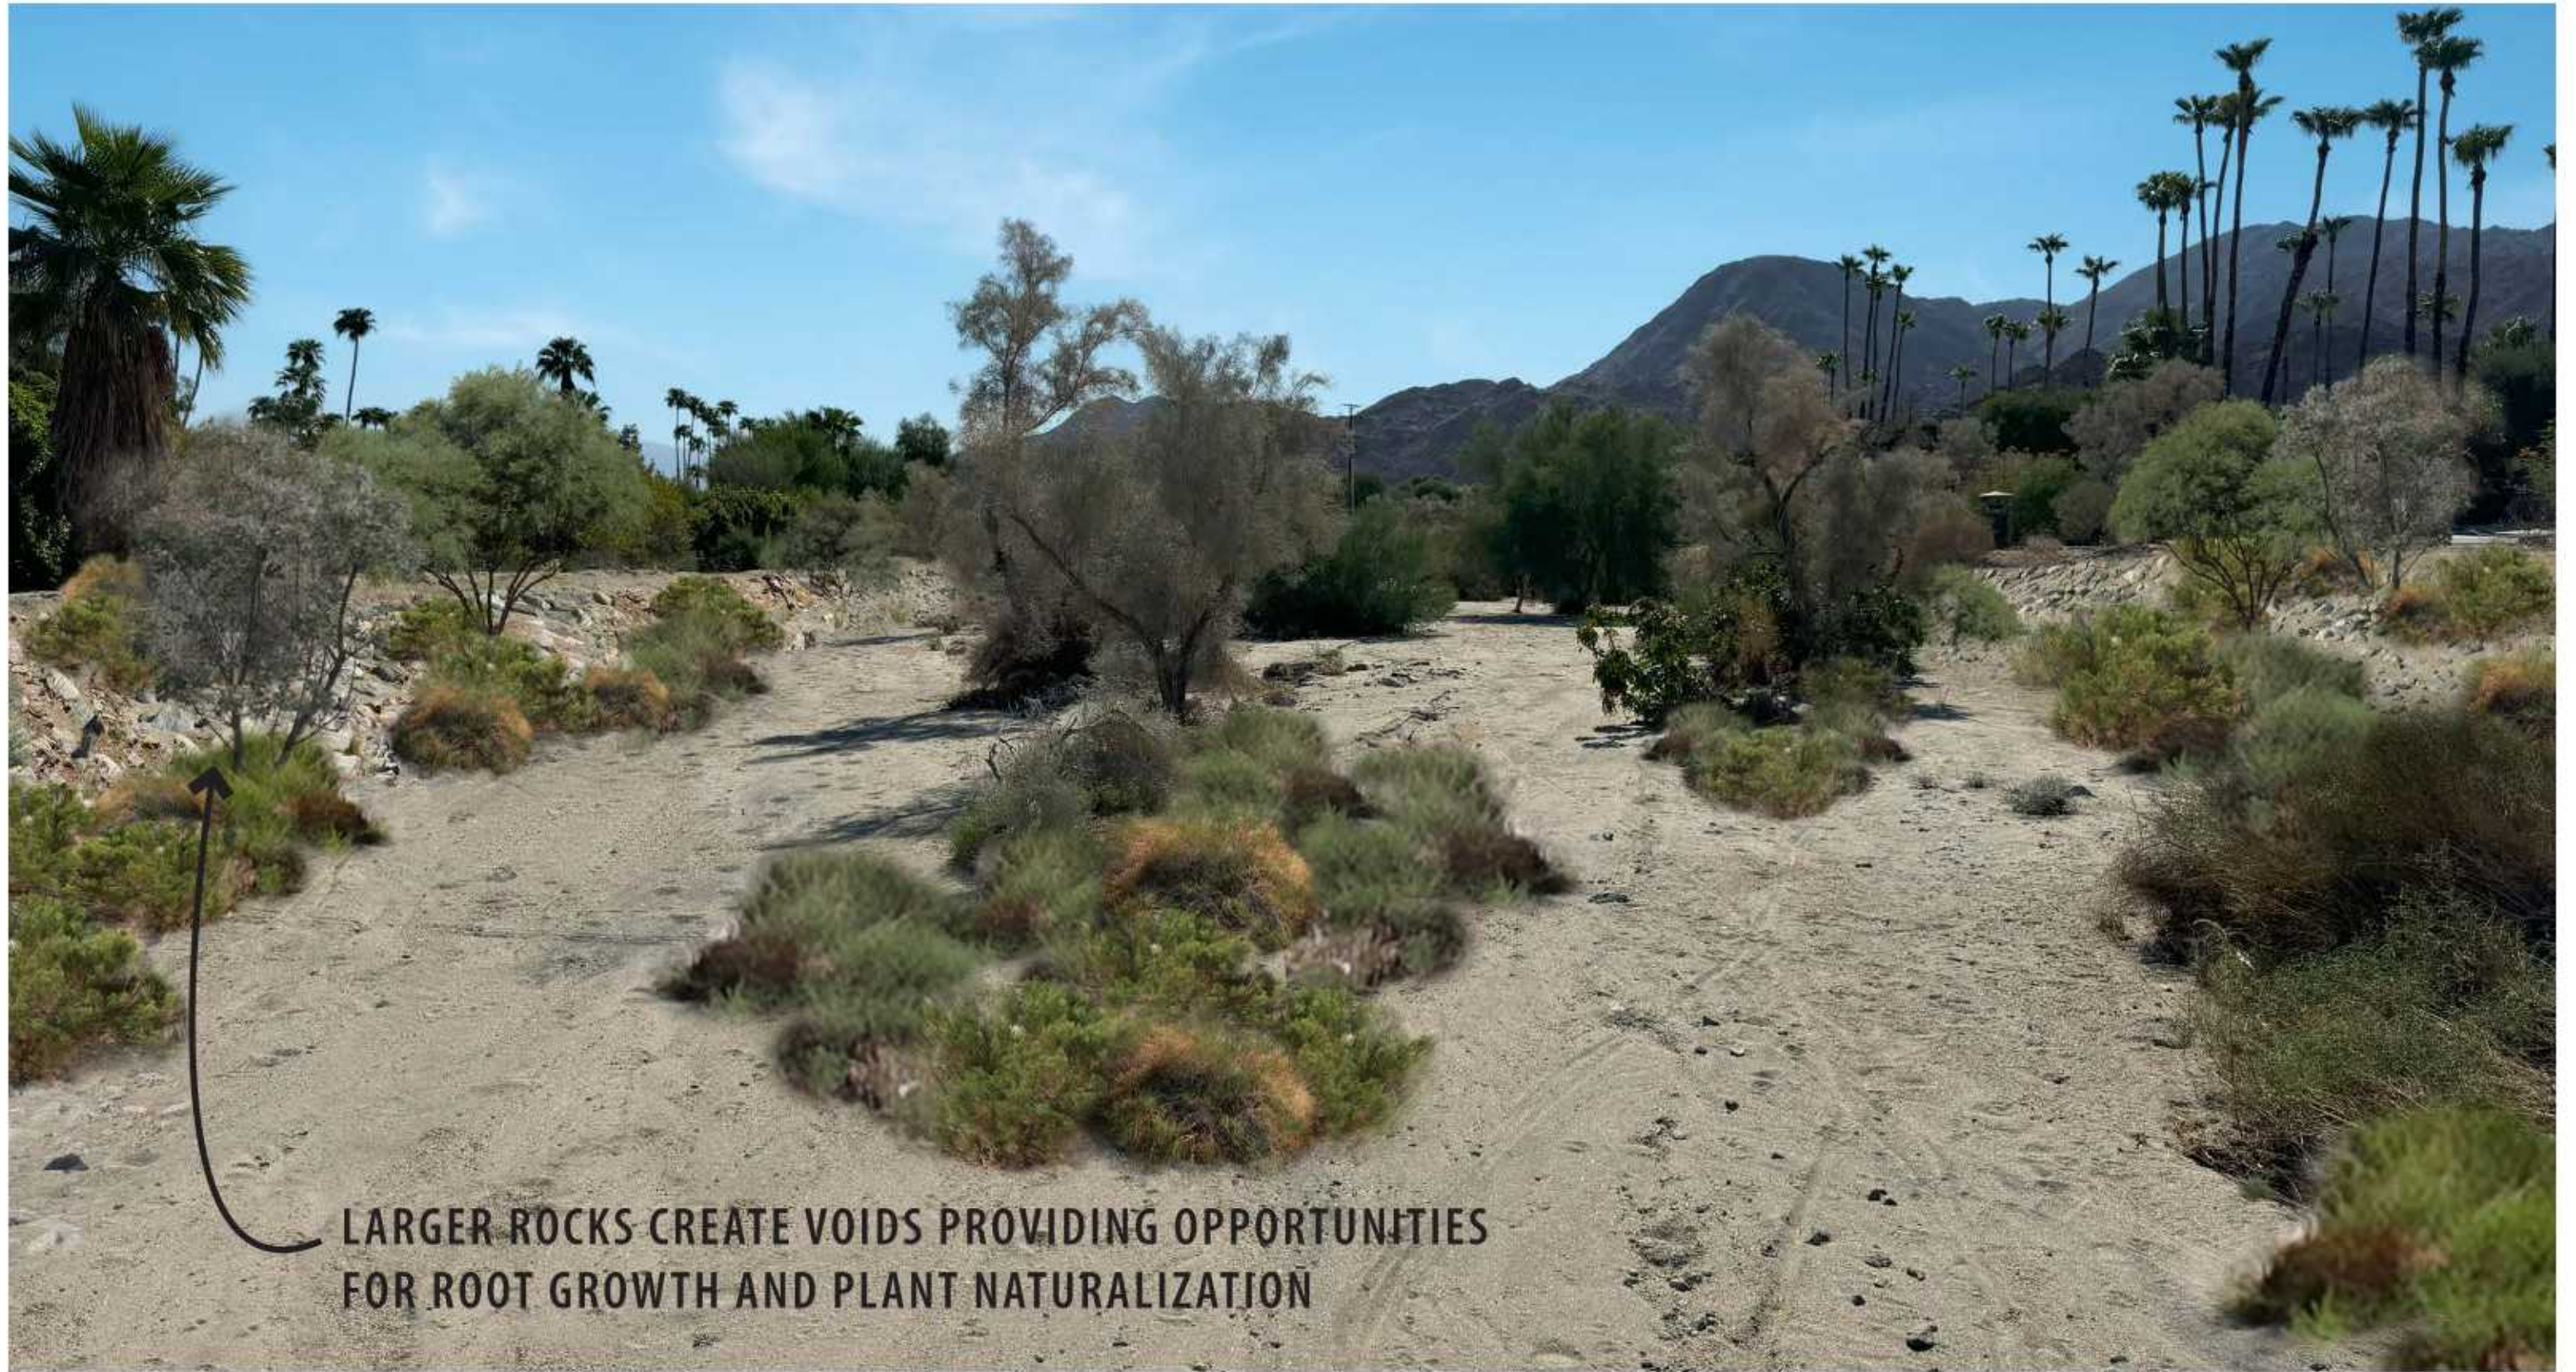
PHOTO 7 PROPOSED CHANNEL IMPROVEMENTS AT MATURITY

LARGER ROCKS CREATE VOIDS PROVIDING OPPORTUNITIES FOR ROOT GROWTH AND PLANT NATURALIZATION
